# Manhole Inspection Summary

Manhole # S45WW\_016MH

Insp Date: **2/9/07 8:39 AM**

**Location** Address: **1729 31ST ST**

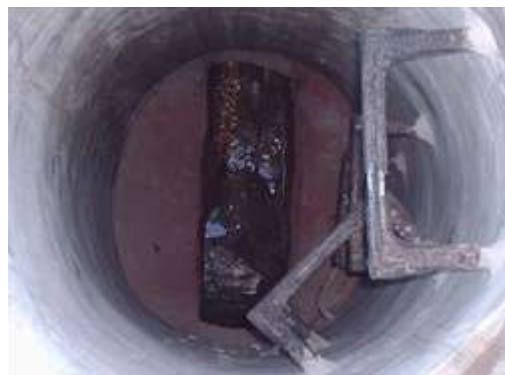
Top View

Barrel infiltration. Bench debris.

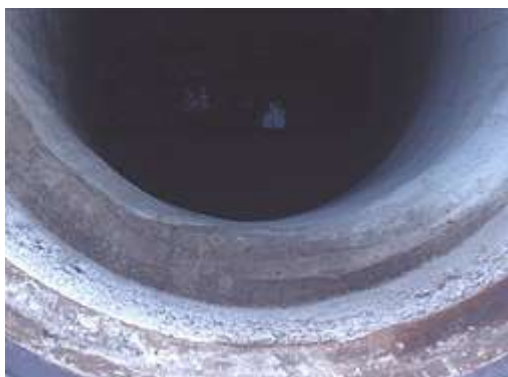
Defect

Frame leaks. Frame offset.

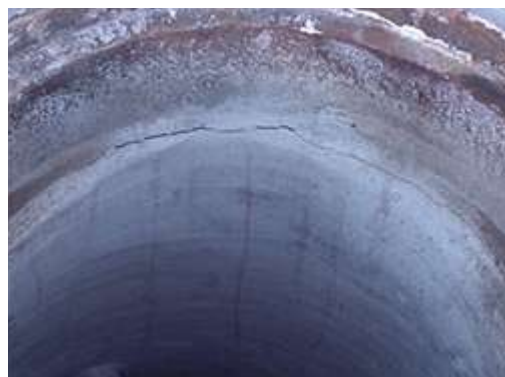
Defect

Frame leaks. Corbel infiltration.

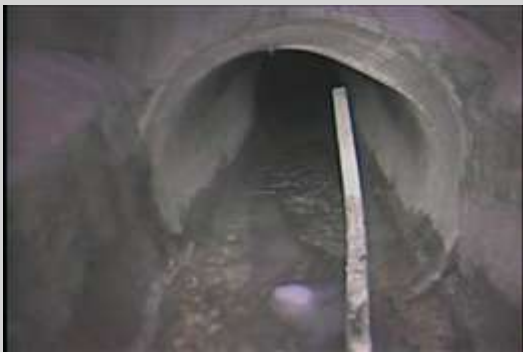
### 12 in. Circular Gravity Sewer Pipe Out @ 12 O'Clock

Deposits: ☐ None ☒ **Mud** ☐ Sludge ☒ **Debris** ☐ Grease

Silt Depth: **0.5** (in.) Deposits Extent: **Light**

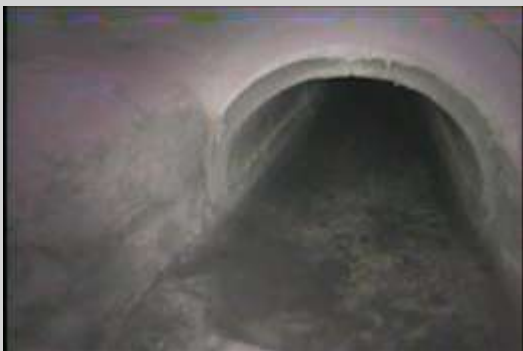
### 12 in. Circular Gravity Sewer Pipe In @ 6 O'Clock

Deposits: ☐ None ☒ **Mud** ☐ Sludge ☒ **Debris** ☐ Grease

Silt Depth: **0.5** (in.) Deposits Extent: **Light**
